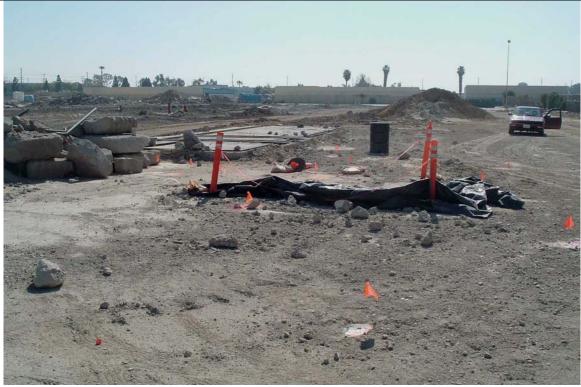
AOI 25 - Hazardous Materials Storage Area Pad area located in the north end of Former Warehouse No. 3 looking south. This area is impacted with metals, PCBs in soil and VOCs in soil gas.

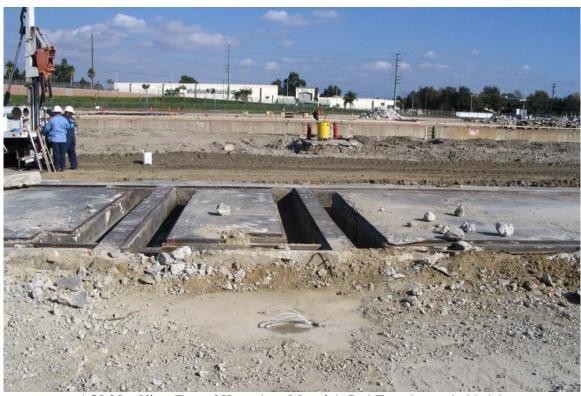
AOI 25 – View East of Hazardous Materials Pad Trenches and old slab beneath Warehouse No.3.

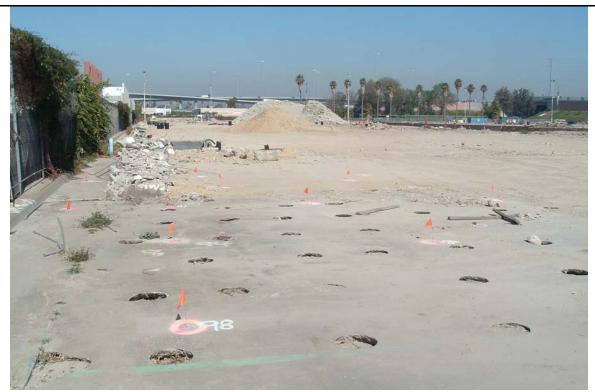
AOI 27 – View North of Former Hazardous Waste Storage Area impacted with PCBs impacted soil and concrete in the southwest corner of Former Warehouse No. 3.

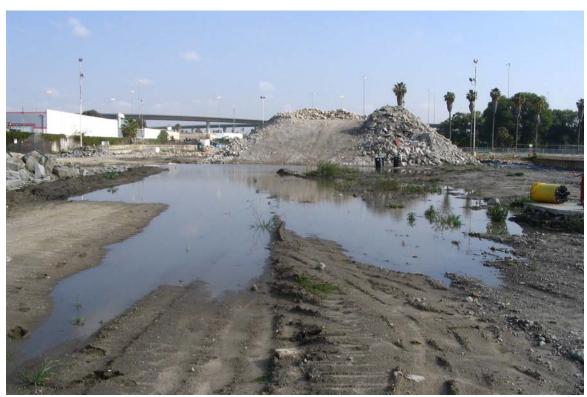
View North of Former Oil Pump House (AOI 41) and Red Lead Shed (AOI 40) and Concrete stockpile located on former loading dock off northwest corner of the Main Building.

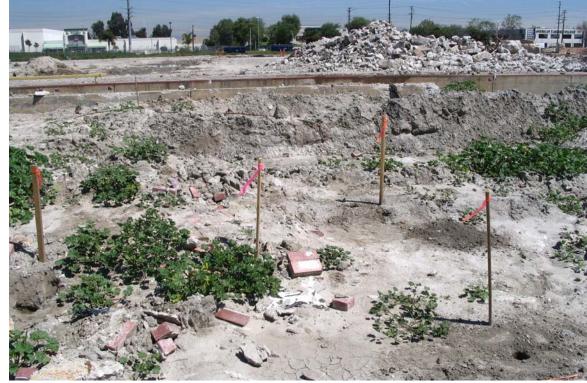
AOI 43 – View east of Cooling Tower & Basin for Plastic Molding Former Process Pit showing GS0025 and associated set-out samples. This area is impacted with metals, PCBs, SVOCs, and PAHs.

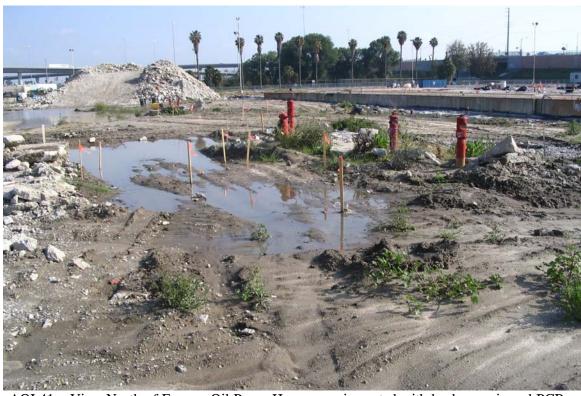
AOI 41 - View North of Former Oil Pump House area impacted with lead, arsenic and PCBs.

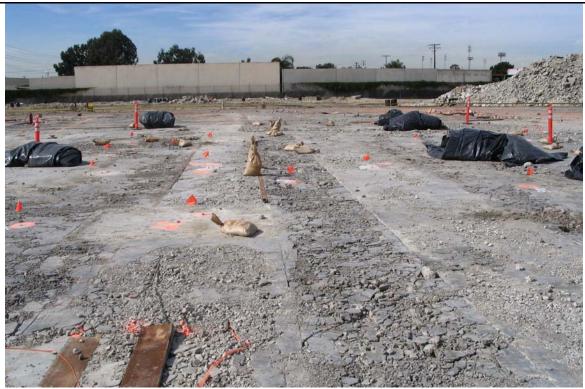
AOI 10: View West of Forklift Repair Area PCB impacted concrete and showing strips of replaced concrete.

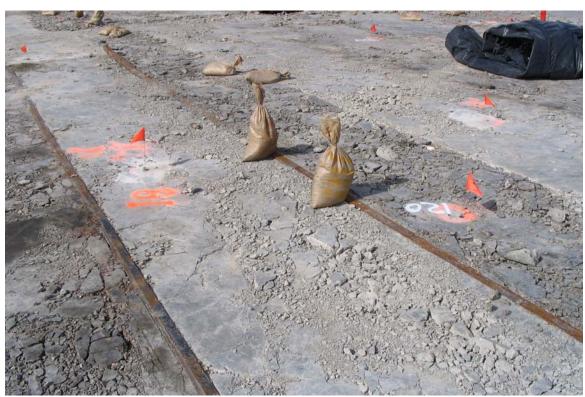
AOI 10. Former Forklift repair area showing contrast between the older and darker PCB impacted concrete and the lighter more recent replaced concrete. Core samples are denoted by flags.

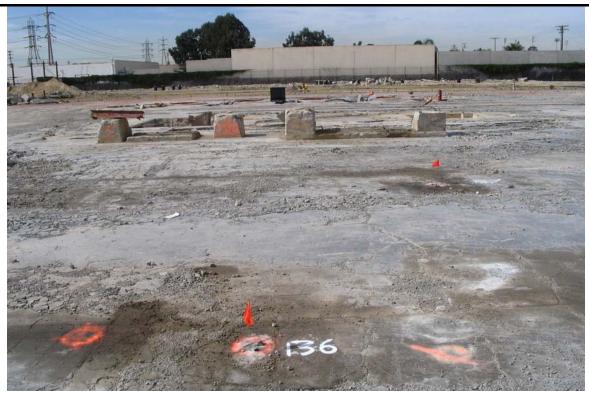
AOI 6: View West of Former Oxide Room Area within Main Building showing stained concrete and oxide grinder footings.

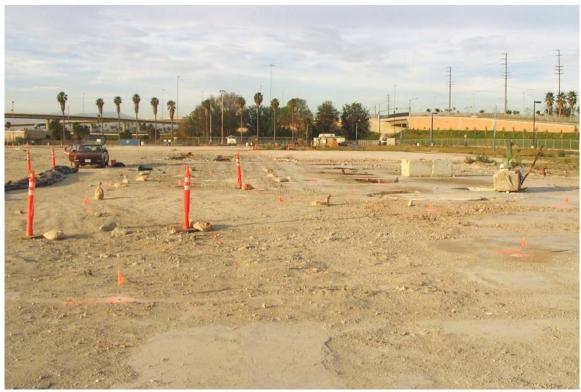
AOI 13: View North of Cast on Strap (COS) area on right and PCB impacted concrete (on left) in the Southeast part of the Main Building.

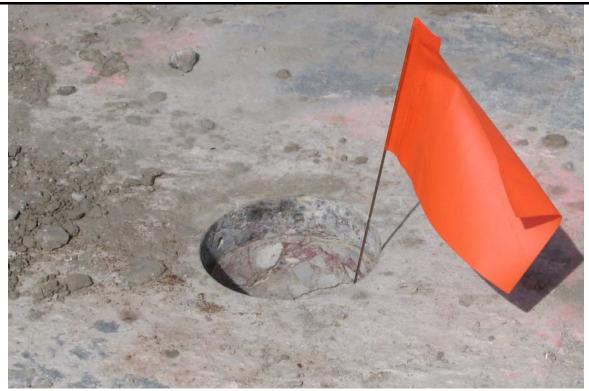
AOI 13 Area PCB impacted concrete in the southeast part of the Main Building showing a a more recent 1-inch layer of concrete on top of purple stained PCB impacted concrete beneath.

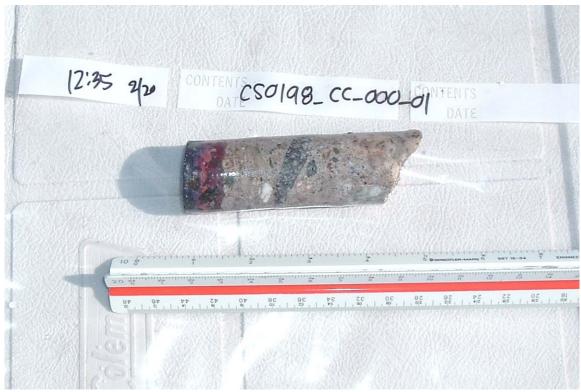
AOI 13: PCB impacted concrete core sample from south end of Main Building showing penetration of PCB containing material.
